Klamath National Forest – Fisheries

Update to NMFS on Coho Critical Habitat conditions post July 2015 storm events

Prepared by: Bobbie DiMonte Miller, Fisheries Program Manager

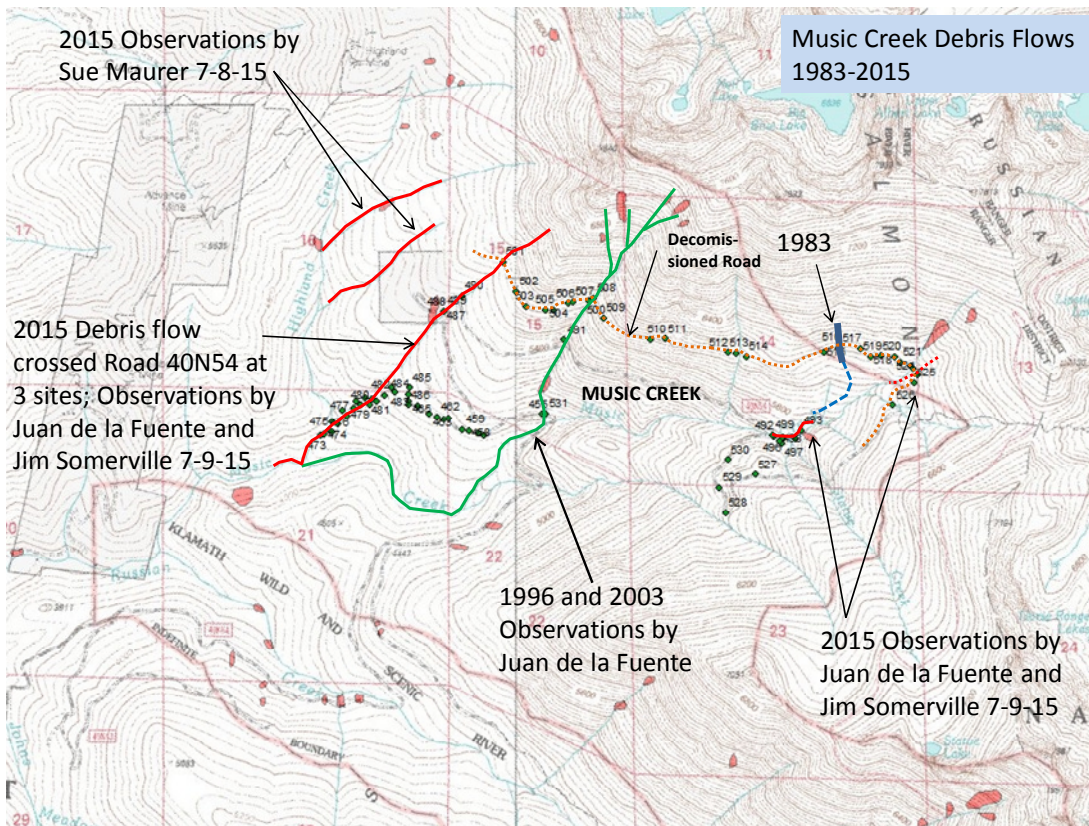
Large debris flow in tributary to Highland Creek average 8' deep in a channel 20-30 feet wide and gradient of 45%. Blocked two legs of switchback [on 45N54]. This was a sediment bulking debris flow. Similar debris flows occurred in 1996 and 2003 in a small stream just east of this year's event. Extensive small fans deposited on road at channels and also between channels. Large culvert blocked on Music Creek and pond 200 feet long formed. The culvert was opened around July 14. Trailhead at end of road buried with debris by stream diversion down the road.

Figure 1. Map showing recent and several past debris flow events in Highland Creek area. Even more extensive debris flows occurred in this area in the 1964 flood event. Courtesy of Juan de la Fuente.

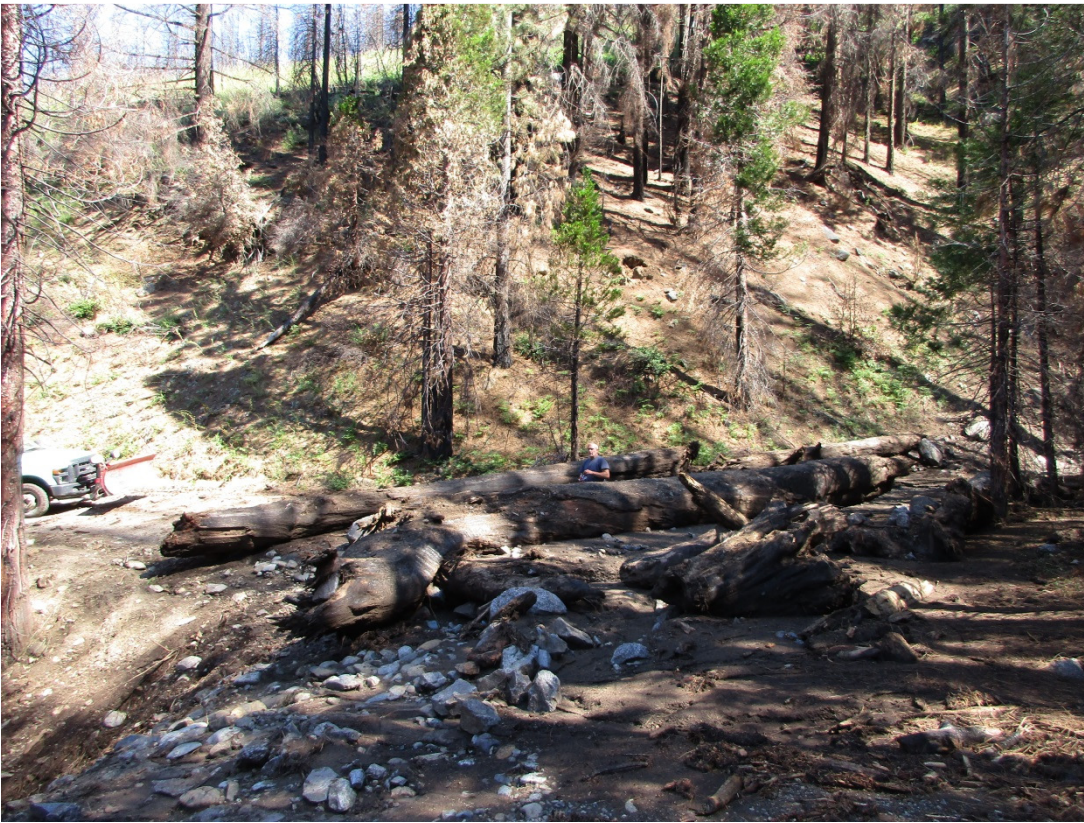
Figure 2. Debris flow deposit on 40N54, photo taken 7/8/2015.

Emergency actions taken to address the situation included clearing roadways and reincorporating excess dirt/fill back into the road prism where possible and otherwise stockpiling the material (outside of Riparian Reserves). Recent BAER treatments on roads, such as rocked dips, were found to have performed very well. Armoring of fills at culvert outlets at stream crossings with large rip rap saved road fills from failure.

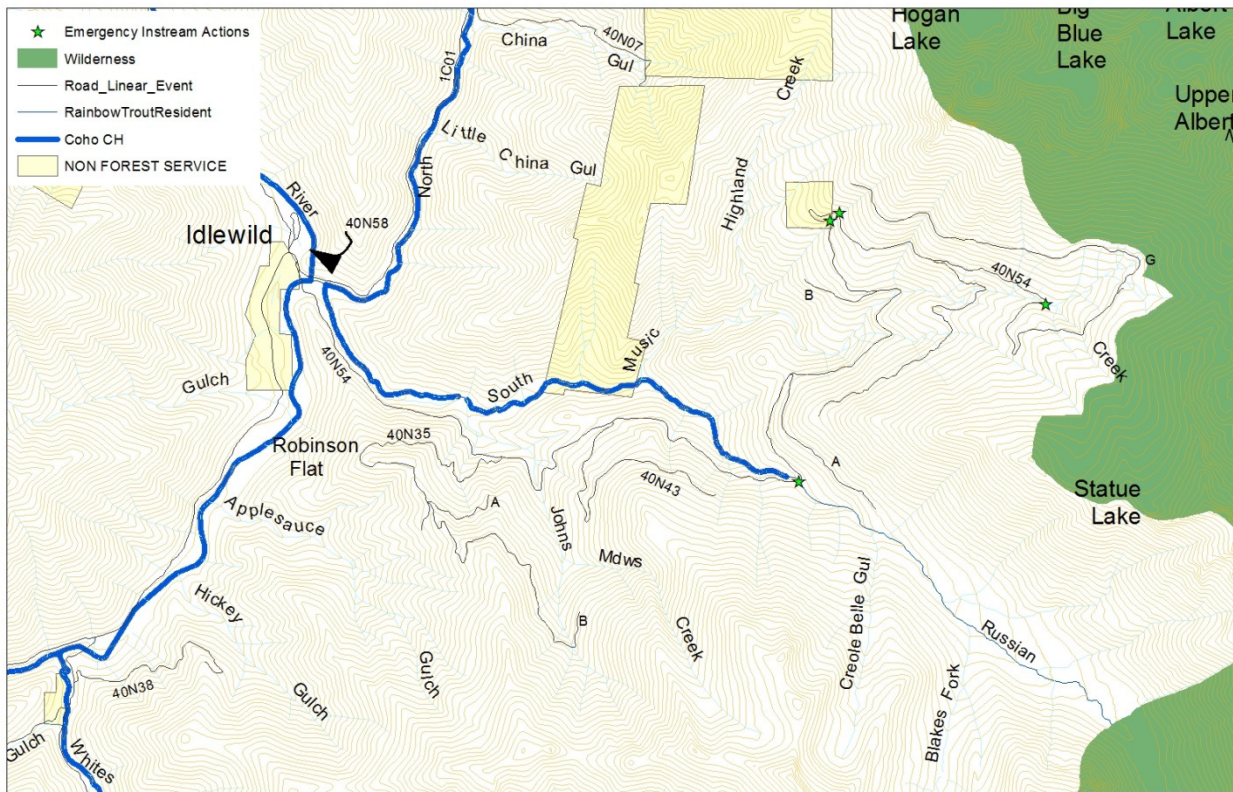
Figure 3. Location of instream emergency actions in Highland Creek/South Russian Creek area.

At one site on South Russian Creek and one site on Highland Creek, instream work in a live stream was necessary to unplug blocked culverts and remove debris. Figure 3 displays where instream actions were necessary. At the site highest up on 40N54, the culvert was completely blocked and a large pond was forming and saturating the road fill (details in Geology report). Going down the road toward South Russian Creek, at the two sites where the road switches back, instream work was necessary but the channel was dry when the work was performed. The lowest site where instream action was needed is just above the upstream extent of Coho salmon CH in South Russian Creek. At this location, the crossing was partially blocked by debris flow and emergency actions involved removing debris from the culvert inlet and outlet and clearing the road way. During these emergency actions in live streams, flows were diverted around the site while work was performed.

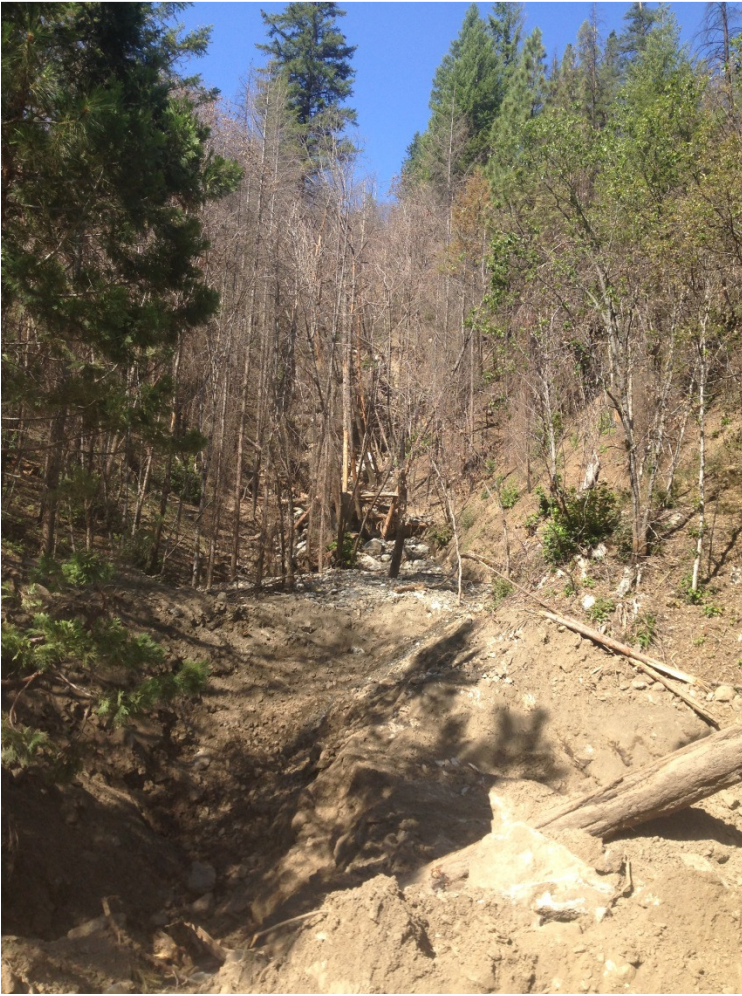
Several tributaries to Beaver Creek, Fish Gulch and Marble Gulch, as well as several face drainages to the Klamath River near Beaver Creek experience accelerated erosion in the form of rilling, gullyng, and debris flows. Debris flows in Fish Gulch and Marble Gulch were relatively large events that moved large logs and rocks greater than 3 feet in diameter, and delivered sediment and large wood to lower Beaver Creek (and private roads and lands adjacent to Beaver Creek). Further upstream and on the east side of Beaver Creek, Buckhorn Gulch and Polly Gulch also experienced debris flows, these events did not involve roads but also contributed sediment and debris to Coho salmon CH in lower Beaver Creek.

Figure 4. Photo taken 7/21/15 from Beaver Creek County road looking up Marble Gulch. In July 2015, similar debris flow events occurred in many small gulches and tributaries to Beaver Creek and the Klamath River in the Beaver Fire area.

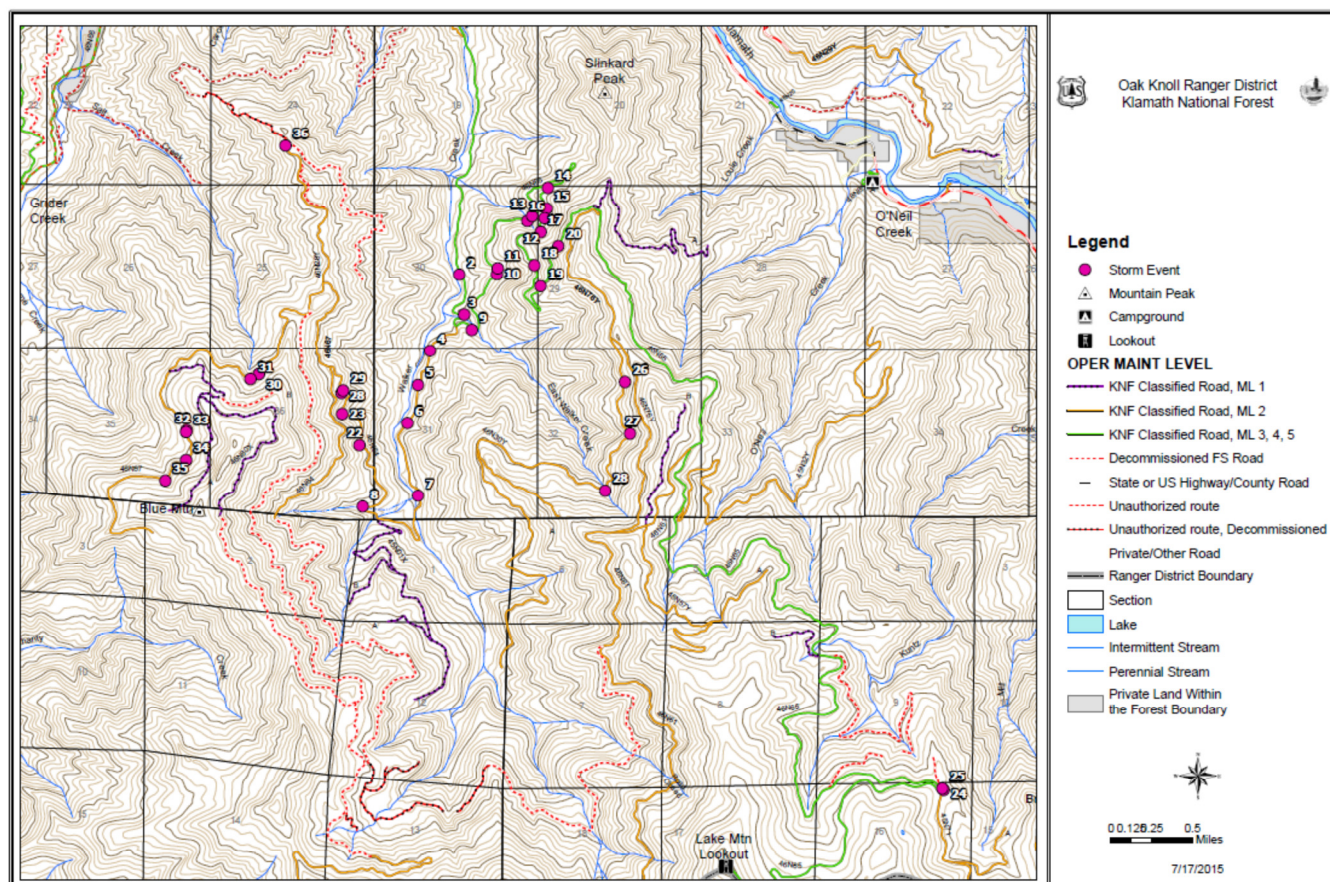
Early in the week of July 6th, again due to intense precipitation over post fire areas, a significant debris flow event occurred in several drainages of Walker Creek, including East Walker Creek and several tributaries draining the west side of Walker Creek watershed. At the location of the first crossing of East Walker Creek when driving 46N64 from Highway 96, the debris flow blocked the culverts and swept over the road depositing debris on the roadway and below to the confluence with Walker Creek. This crossing, and the one above it on 46N65, were overtopped and clogged with large rocks, wood and sediment. The debris flow was about 8 feet deep as it traveled through its channel above the crossings, and it buried the crossings with about 1 foot of debris. These crossings were compromised but did not fail. Engineers estimated that approximately 5 cubic yards of road fill was lost at each crossing, and about 2000 cubic yards of sediment and debris had to be removed to recover and clear the crossing and road. Excess material was stockpiled at the large old landing near East Walker Creek (site #3 in figure below).

Figure 5. Map showing sites of emergency road repair in Walker Creek area.

Emergency actions in live streams were required at several sites on East Walker Creek; these sites are labeled as # 3 and 9 in Figure 5 above. On the west side of Walker Creek, emergency actions in live streams were required at sites #8 and 23. During these emergency actions in live streams, flows were diverted around the site while work was performed.

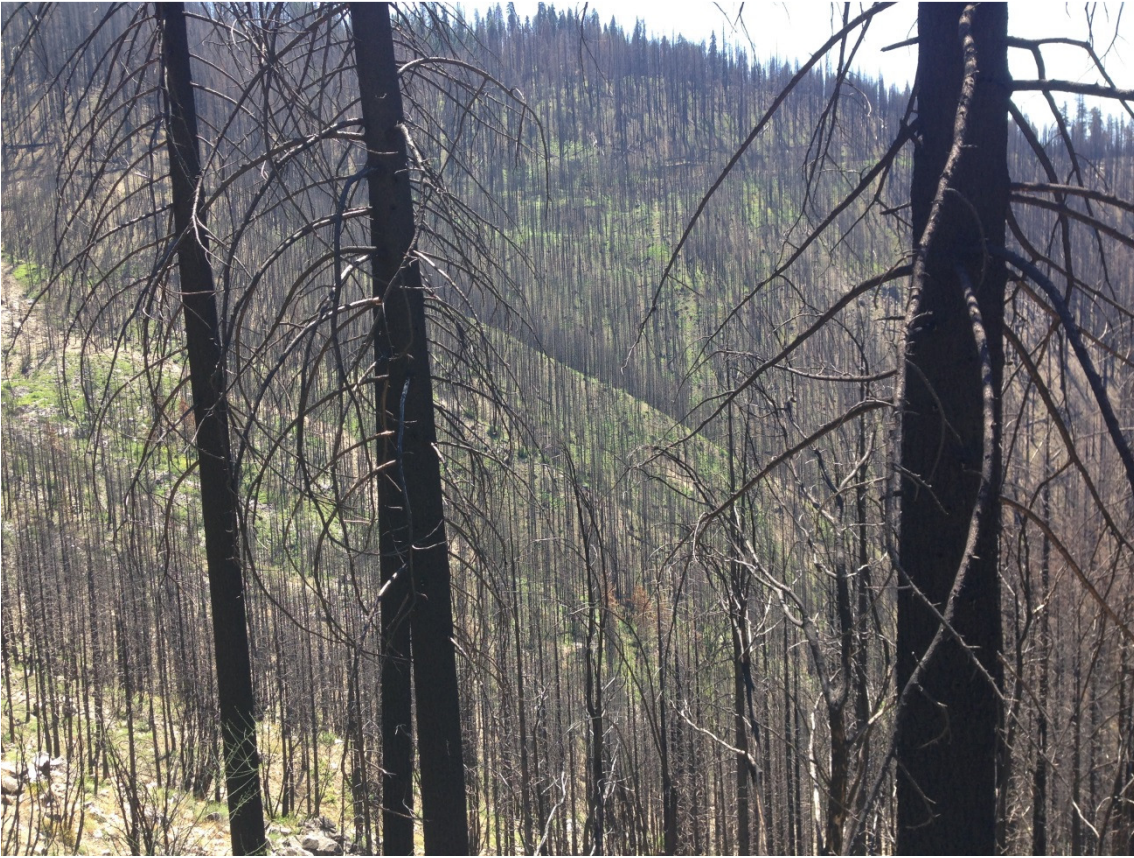
Figure 6. Upper No Name Creek drainage on 7/21/2015. Debris flow initiated above the road, near the top of the drainage, and can be seen in the middle left of this photo behind the burned trees in foreground.

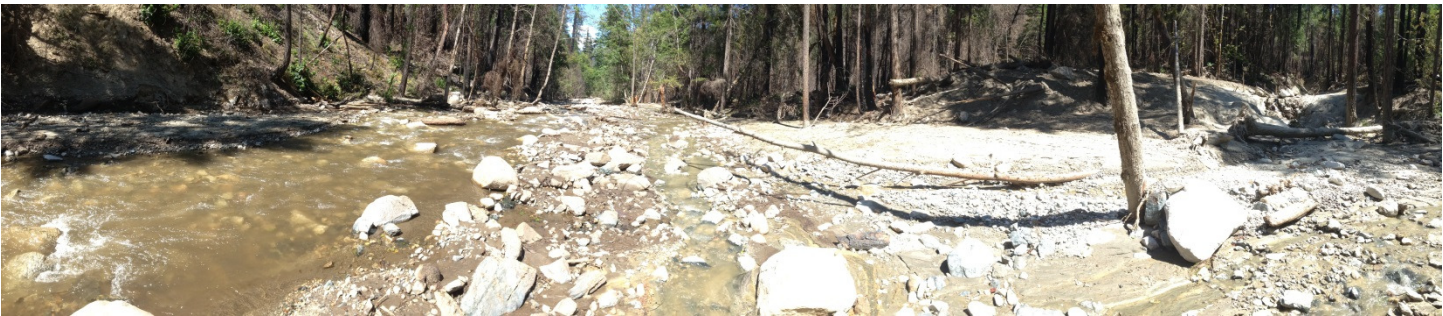
Figure 7. Panoramic photo of confluence of No Name Creek and Grider Creek. Taken 7/21/2015.

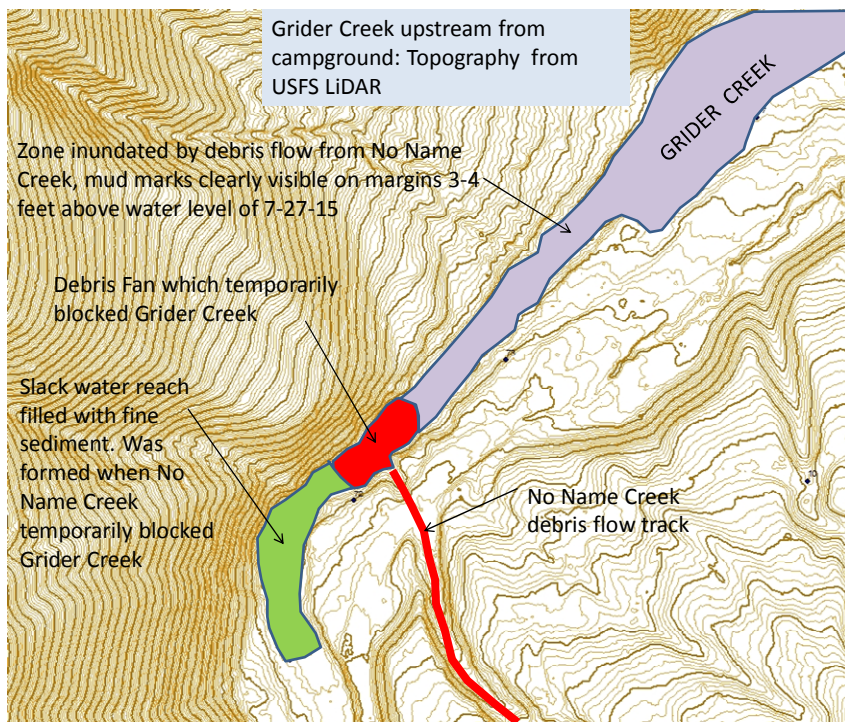
Figure 8. Schematic of debris flow deposition in Grider Creek. Courtesy of Juan dela Fuente.

Roads played little to no role in this debris flow event in Grider Creek. The Forest’s primary concern for infrastructure and public safety relates to the campground just downstream of No Name Creek confluence. The only emergency actions taken by the Forest Service in Grider Creek watershed in response to these events was near the top of No Name Creek drainage on road 40N67. Emergency repair/stabilization involved cleaning out culverts in dry channels and removing sediment and debris from roadways and stockpiling outside of Riparian Reserves.
